APPENDIX D
SITE PHOTOGRAPHS

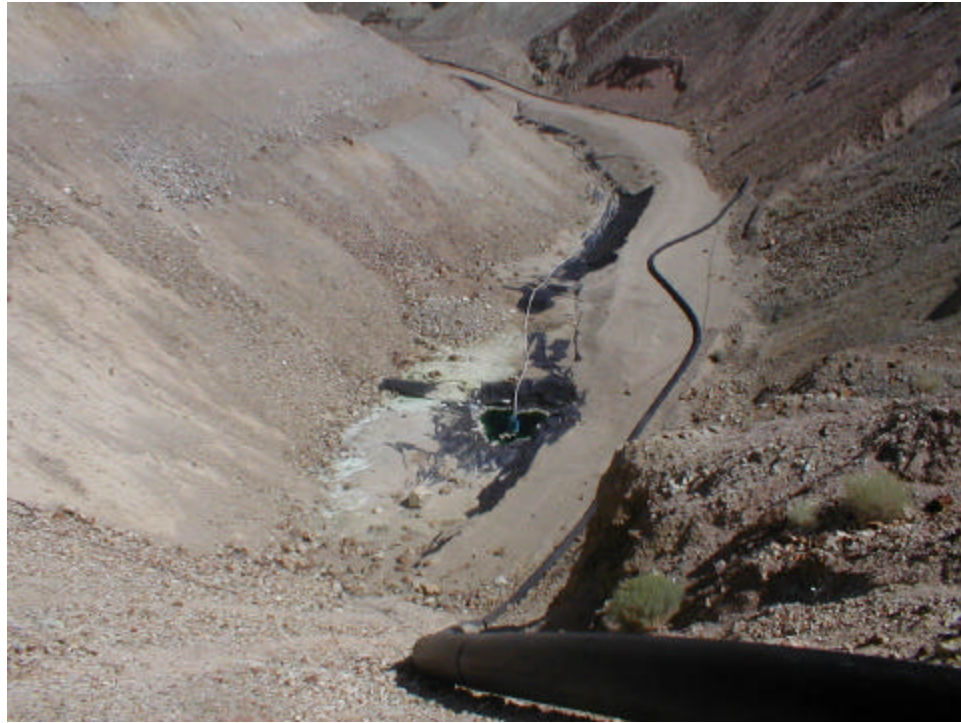
Photo 1

Looking north at sump from Phase I to Phase I/II PLS and disconnected
12" pipe from PLS to Slot Heap

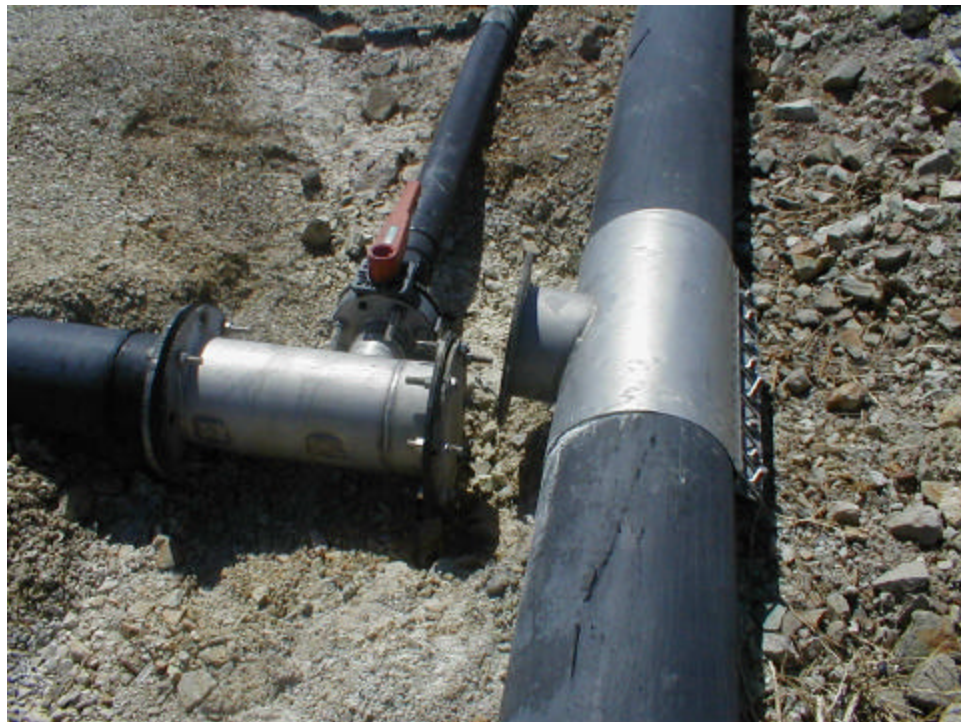
Photo 2

12" fluid transfer from Phase I/II PLS to Slot Heap surface: disconnected
from evaporation system

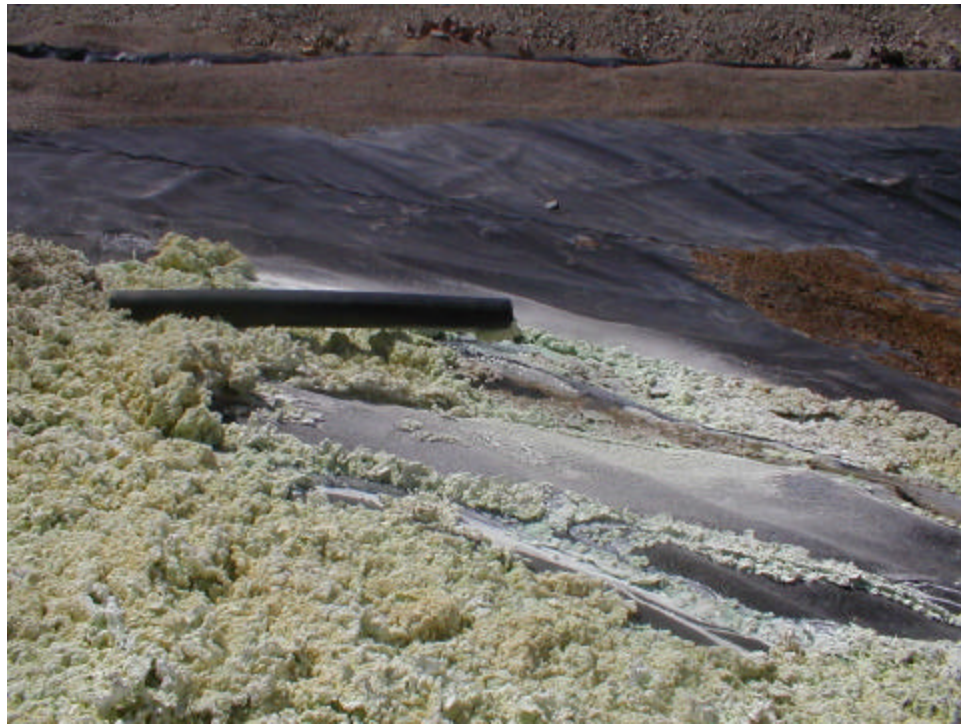
Photo 3
Approximately ½ gpm draining from Phase I sump into Phase I/II PLS
pond

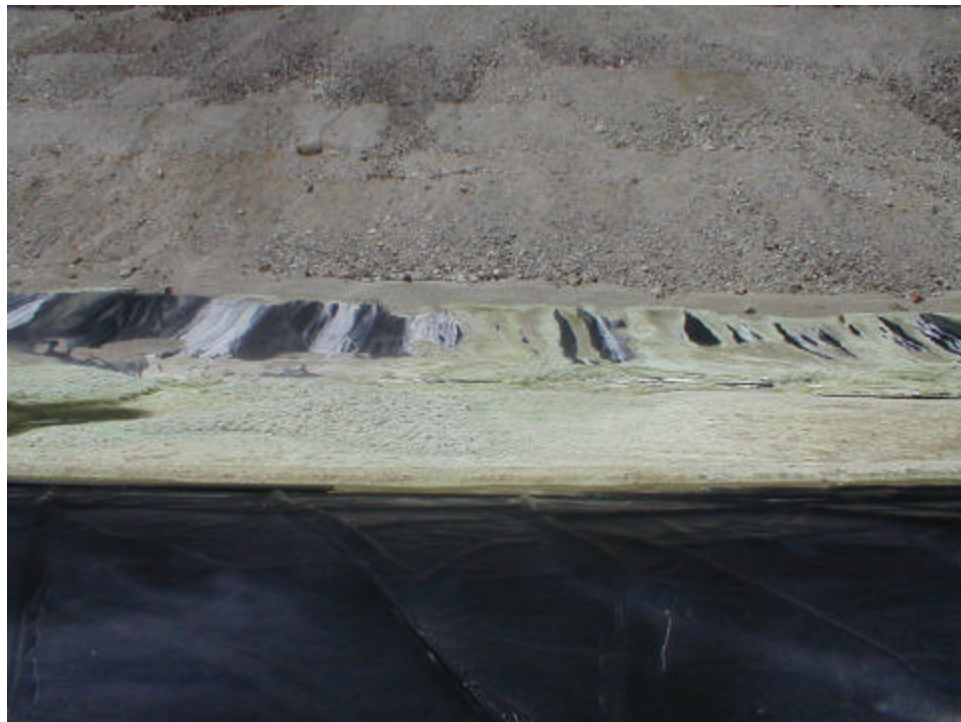
Photo 4
Evaporite in Phase III south “bathtub” basin

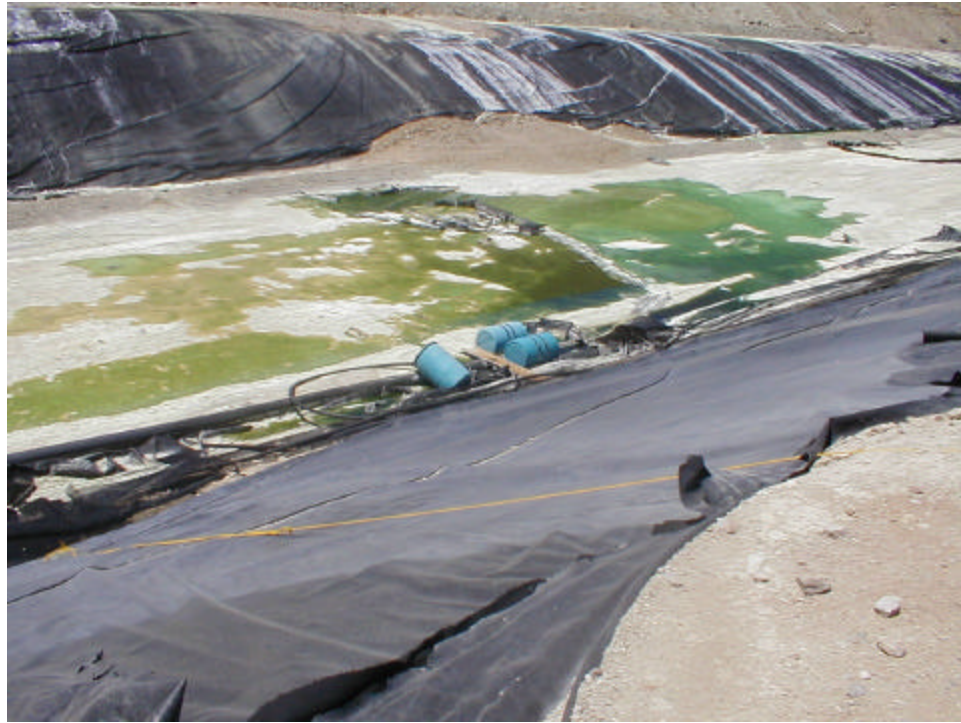
Photo 5
Megapond barge pump and limited standing solution

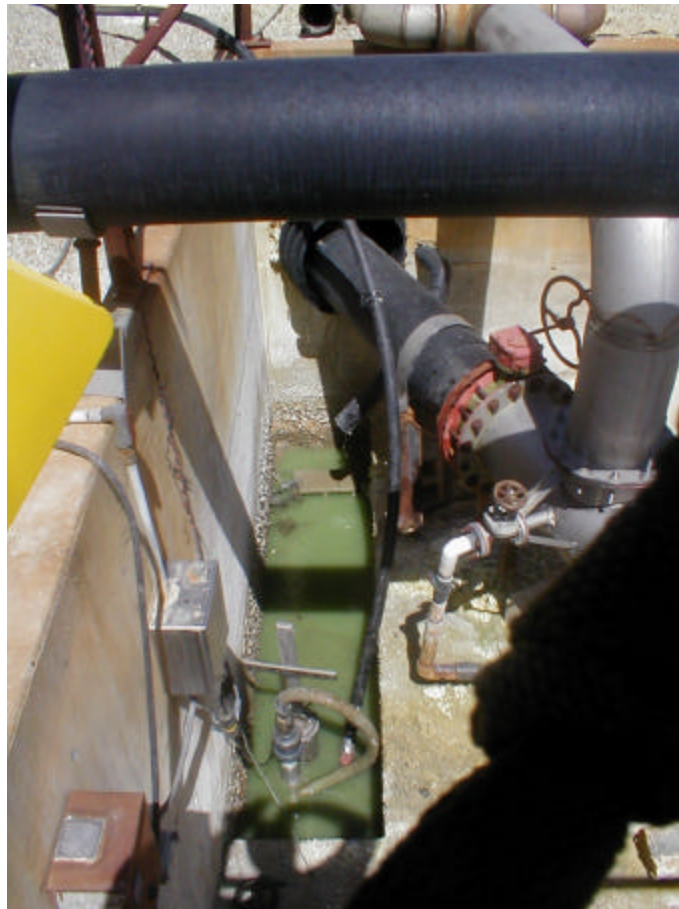
Photo 6
Megapond leak detection/leakage transfer sump

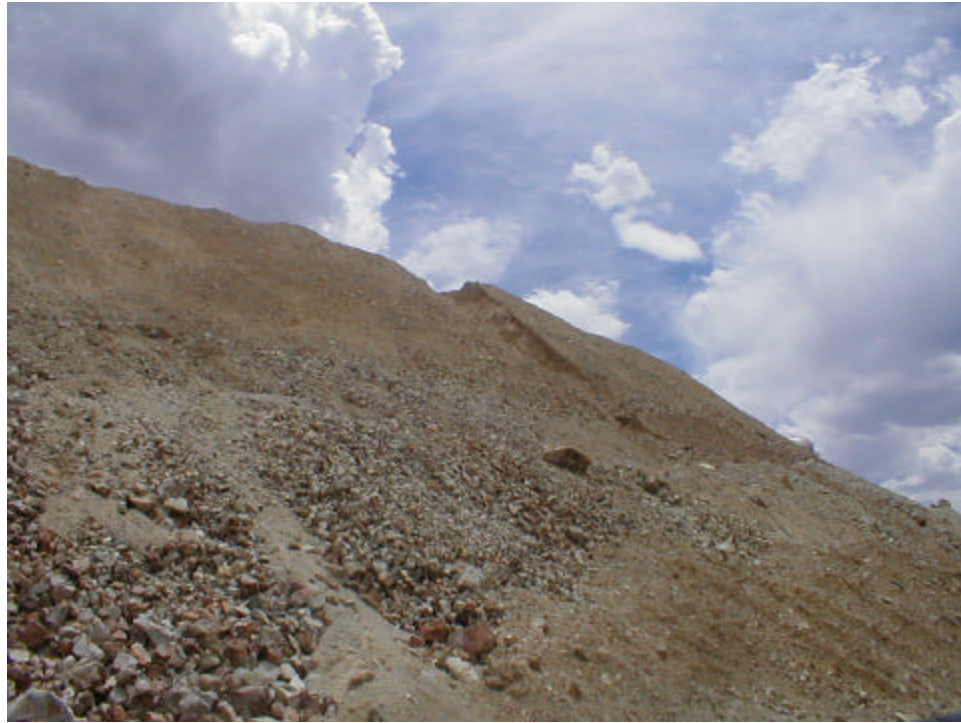
Photo7
Local slope failure on east face of Phase III Heap

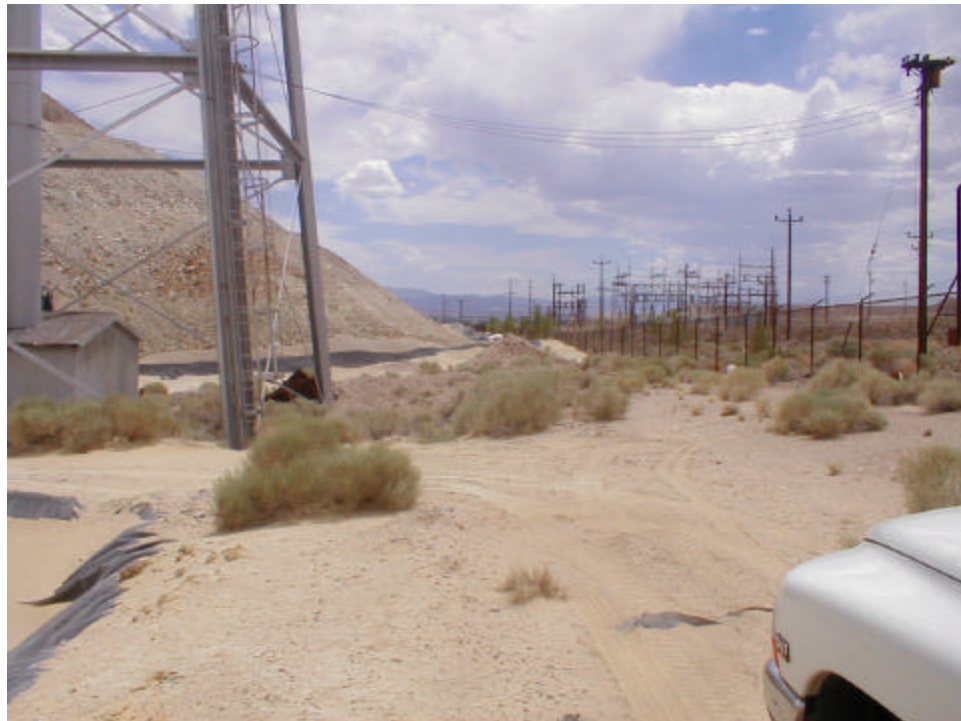
Photo 8
Western toe of Phase III Heap near property boundary (fence) and municipal features (water tank in foreground, Sierra Pacific electrical substation in background)

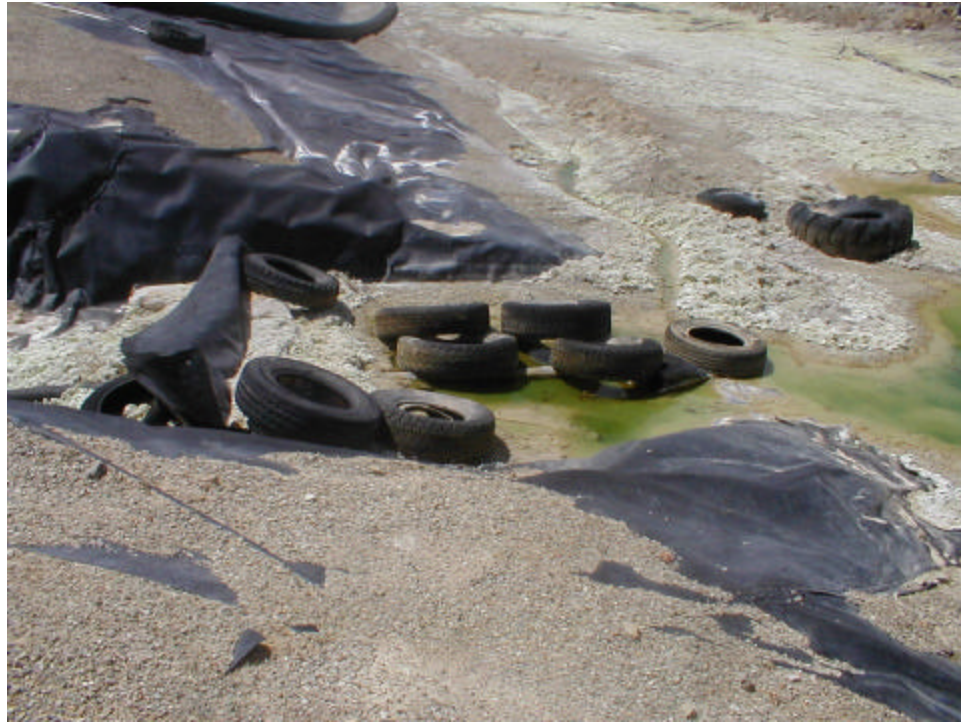
Photo 9
Phase III/4X southeast corner – dam and gravity drain pipe to divert
draindown to VLT system

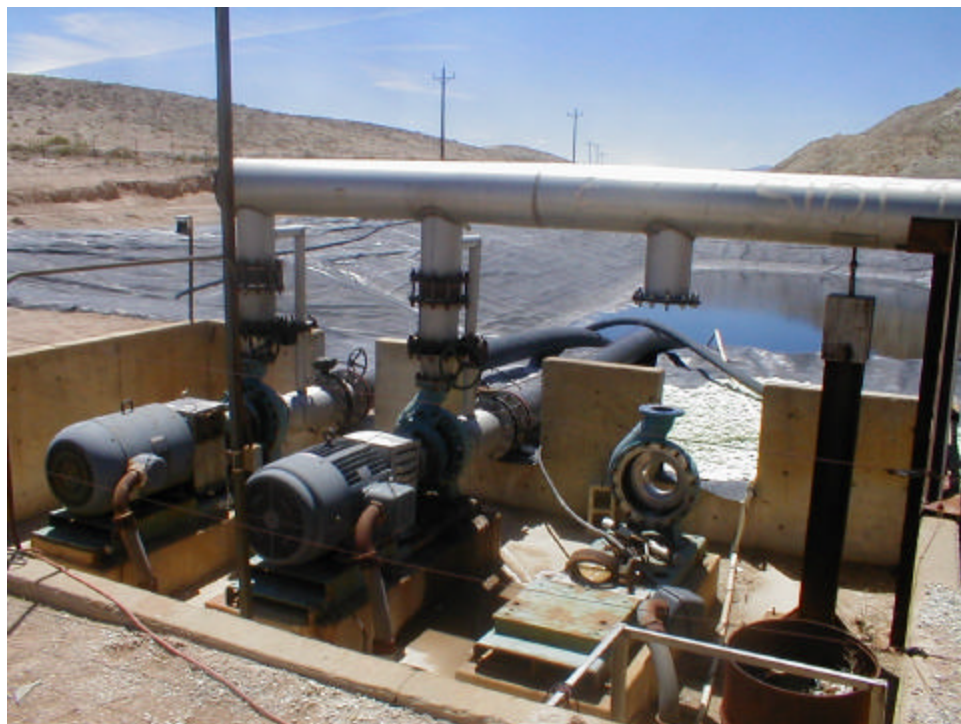
Photo 10
Phase IV-Slot pump station – not currently operated in favor of smaller
pumps

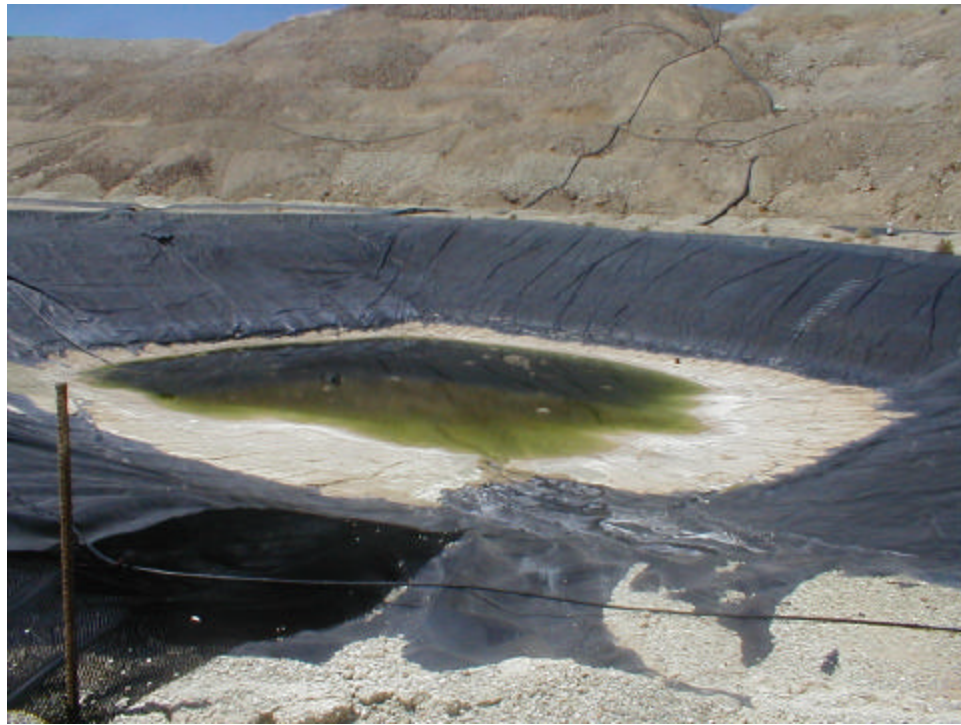
Photo 11
Phase IV-Slot North Pregnant Pond – incidental standing water only, leach
and solution management piping in background

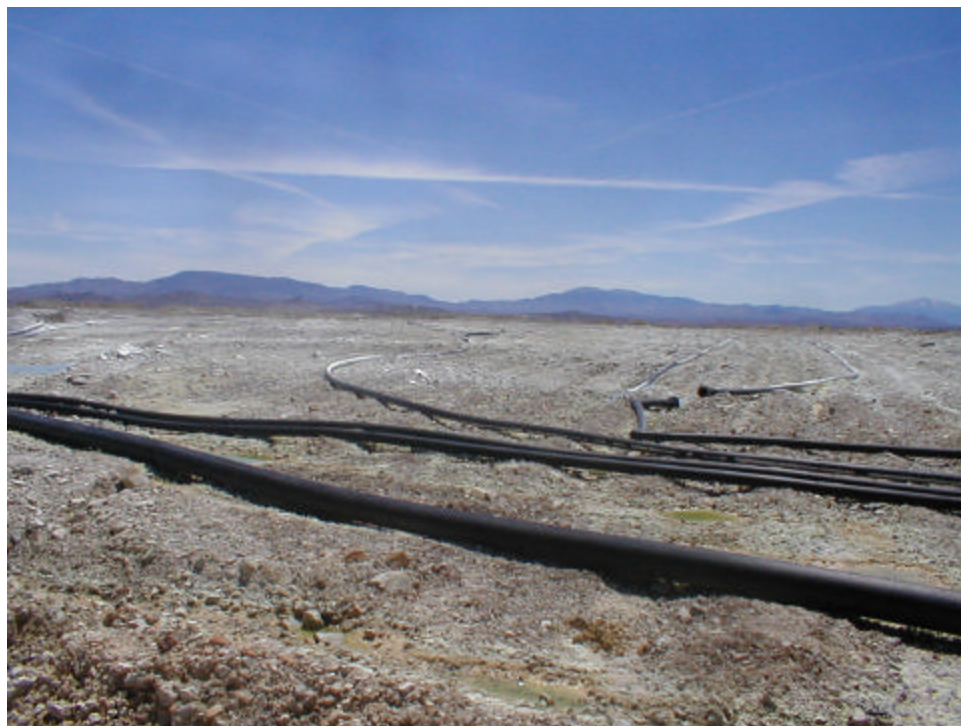
Photo 12
Surface of Phase IV-Slot Heap – evaporation pipes and misters

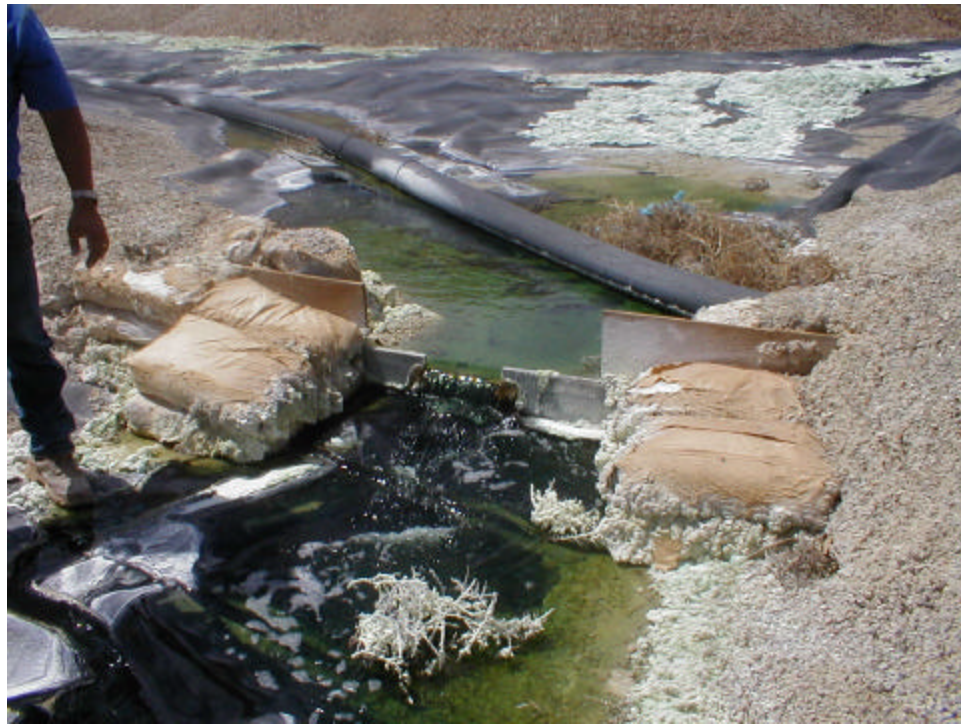
Photo 13
Weir at inlet of Phase IV-VLT solution ditch to VLT sediment control basin

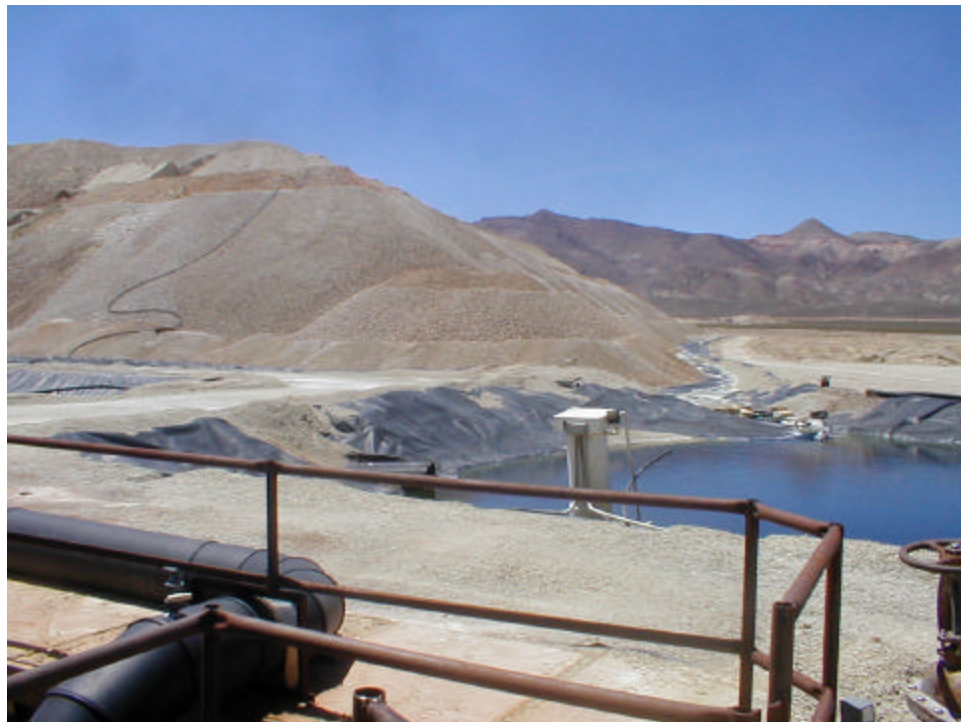
Photo 14
Looking east along north face of Phase IV-VLT Heap, sediment control basin and leak detection port in mid-ground, discharge pipe for buried pump station in foreground

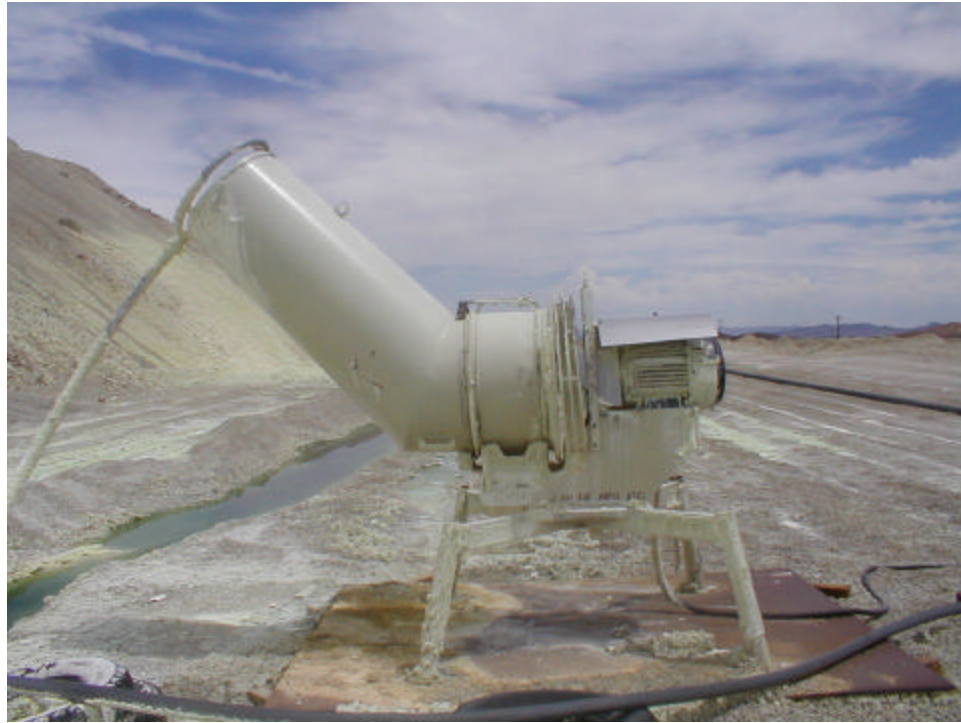
Photo 15
One of two types of high-efficiency evaporators in use on Phase IV-VLT
Heap – not currently operating

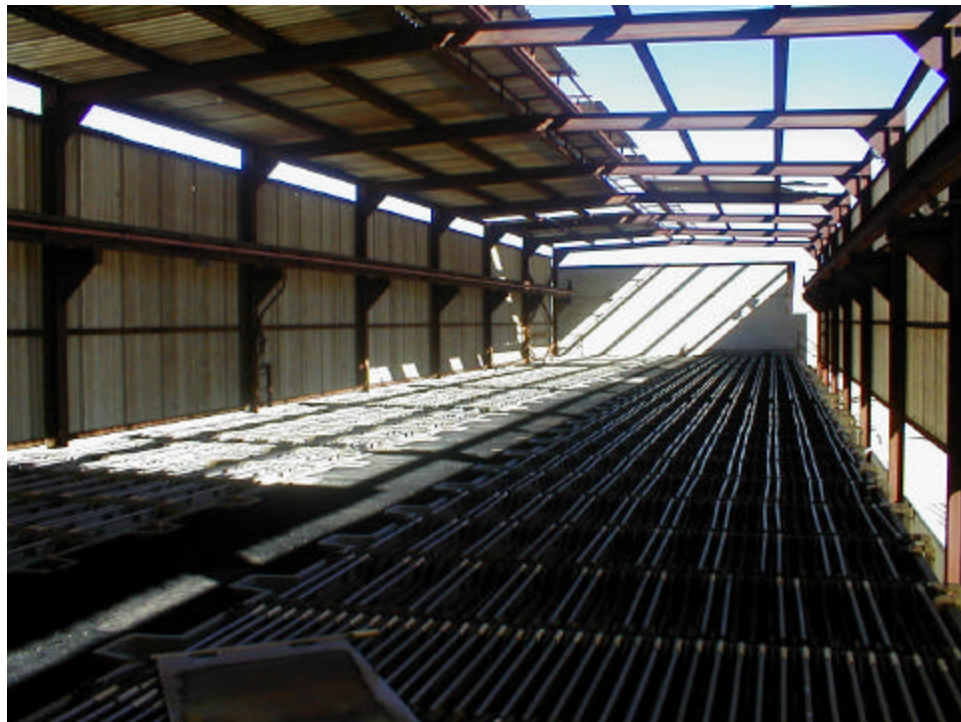
Photo 16
Looking northeast – Interior of SXEW Building

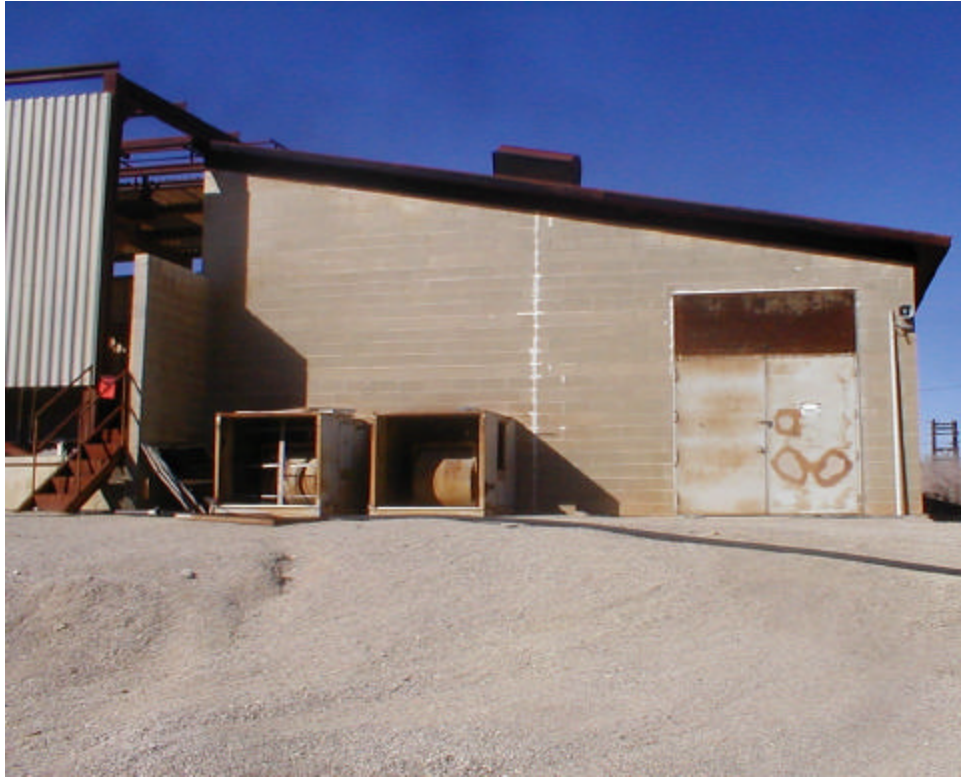
Photo 17
Looking northwest at eastern end of the SXEW Building

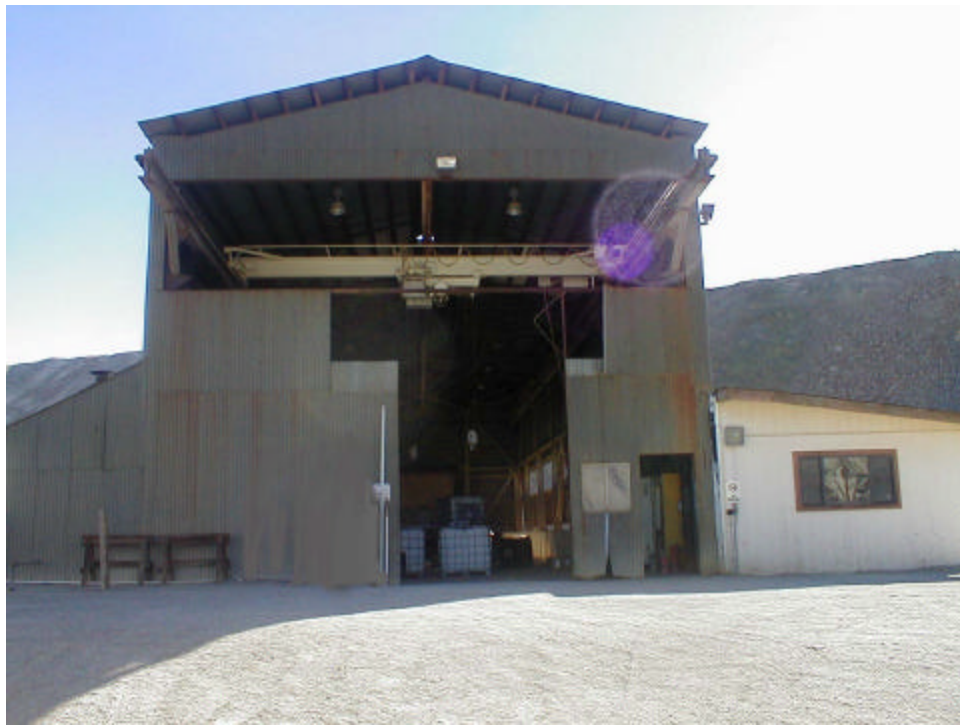
Photo 18
Looking southeast at the laboratory and plant office building
